PHOTOGRAPHIC INTERPRETATION REPORT

SELECTED TRANSPORTATION AND INFILTRATION COMPENDIUM 8-14 SEPTEMBER 1966

NPIC/R-333/66 SEPTEMBER 1966

SUMMARY NO 20

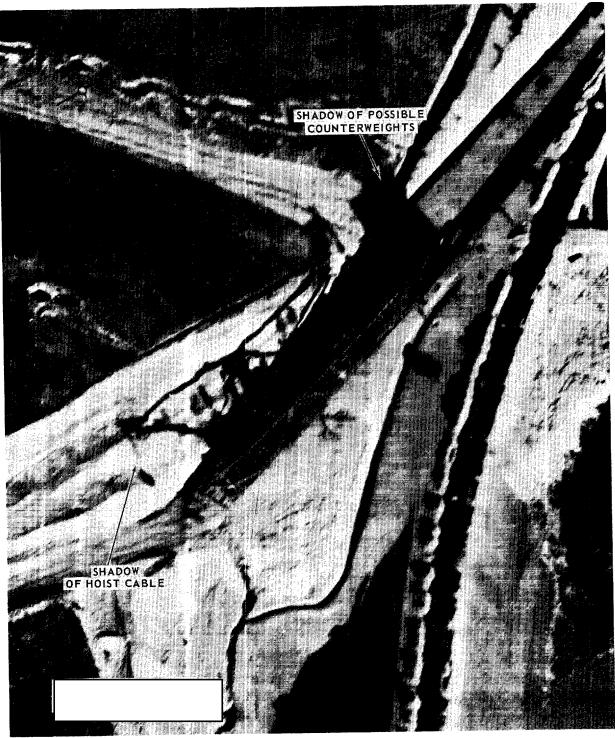
A heavy-duty, rail car-mounted, cantilever crane (Figure 1) approximately 110-ft long is located on a short rail spur at 21-27N 106-14E (UTM XJ283726), immediately southeast of a serviceable 4-span rail bridge over the Song Thuong (river) at 21-27N 106-14E (UTM XJ281726). Examples of similar cranes used in China are shown in Figures 2 and 3.

FIGURE 1. RAIL CAR-MOUNTED CANTILEVER CRANE, KEP/THAI NGUYEN RAIL LINE, NORTH VIETNAM

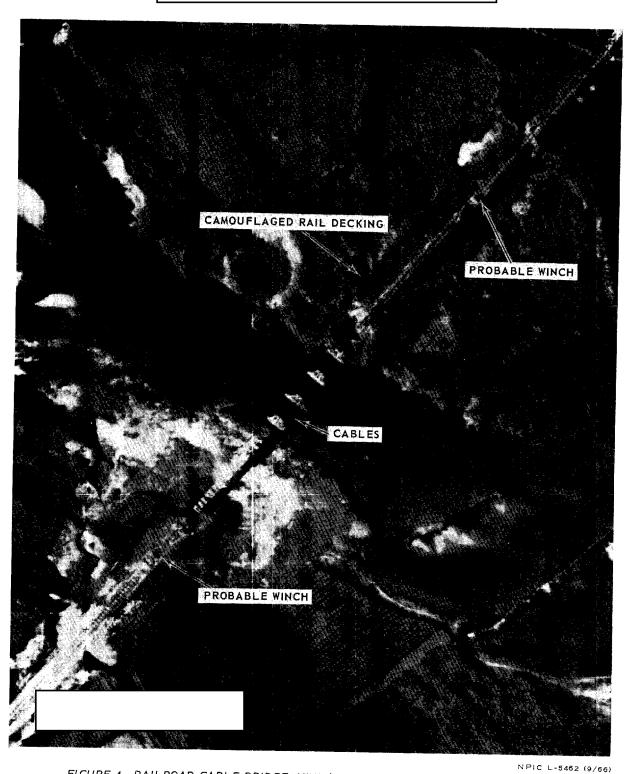
2. Railroad Cable Bridge, Vinh/Dong Hoi Rail Line, North Vietnam
25X1D	Photography of reveals camouflaged rail decking on the western approach of the previously reported railroad cable bridge
25X1A	under construction at Dong Bai Railroad Bridge North over the Song Tiem at 18-09N 105-43E (Figure 4). Probable winches are on both bridge approaches. The eastern approach is unserviceable due to a lack of track and Dong Bai Railroad Bridge over the Song Tiem (BE
25X1A	at 18-09N 105-43E remains unserviceable.
25X1D	Photography of reveals the camouflaged decking placed on the bridge cables and track on the eastern approach (Figure 5). Thus, this cable bridge and associated by-pass around the unserviceable Dong Bai Railroad Bridge are serviceable.
25X1D	NPIC Cable Cite 8431, DIG 1013122, Sep 66 NPIC Briefing Board L-1826

FIGURE 4. RAILROAD CABLE BRIDGE, VINH/DONG HOI RAIL LINE, NORTH VIETNAM

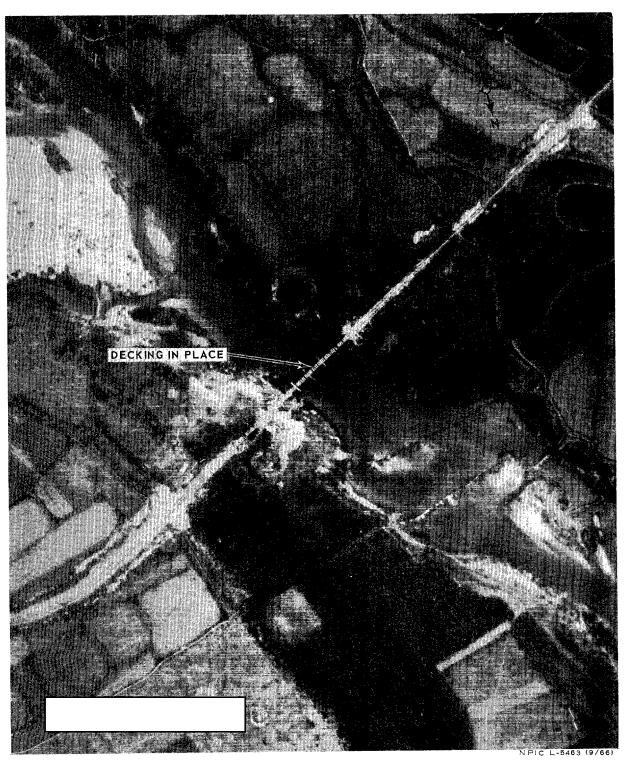
FIGURE 5. RAILROAD CABLE BRIDGE (SERVICEABLE), VINH/DONG HOI RAIL LINE, NORTH VIETNAM

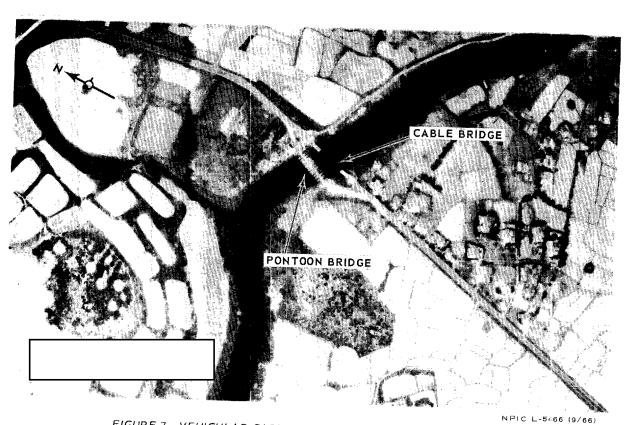
A vehicular cable bridge has been constructed on Route 1, Quang Tri Province, South Vietnam, at 16-52N 107-05E (UTM YD223660). The bridge is similar in construction to those previously identified by NPIC in North Vietnam and Laos (Summary Numbers 17, 18, and 19). At least 4 cables with 3 A-frame supports are observed between the remaining end spans of a previously damaged bridge (Figure 7). A serviceable pontoon bridge is located immediately west of the cable bridge.

FIGURE 7. VEHICULAR CABLE BRIDGE, ROUTE 1, SOUTH VIETNAM

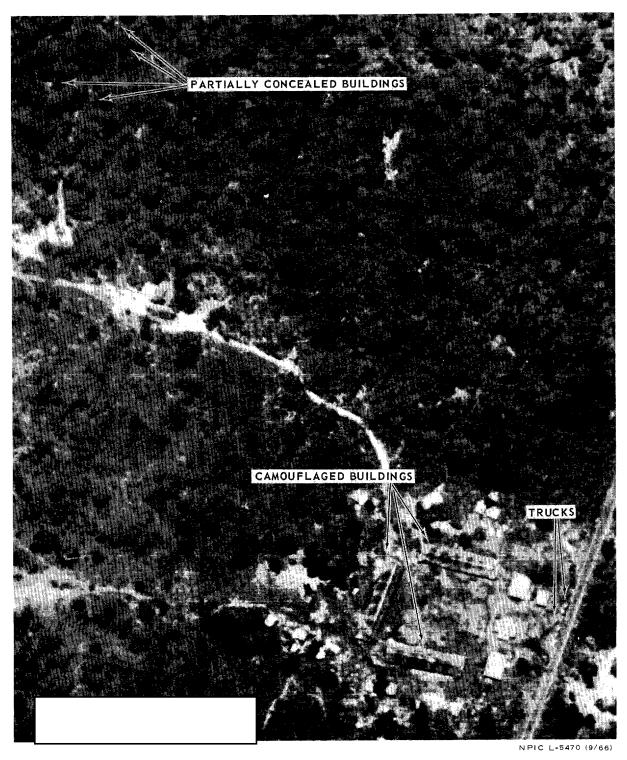
FIGURE 9. PROBABLE CAMBODIAN MILITARY CAMP, KRATIE AREA, CAMBODIA
